**S.C. WRIGHT CONSTRUCTION, INC.**

**PROJECT CONDITION ASSESSMENT AND EVALUATION  
REPORT – NON COMPLETED CONSTRUCTION**

The project located at [REDACTED] was evaluated as an abandoned residential development consisting of 52 Single Family Detached Residences in various stages of construction. The original intent of the development was a 3-phase construction project with the following breakdown:

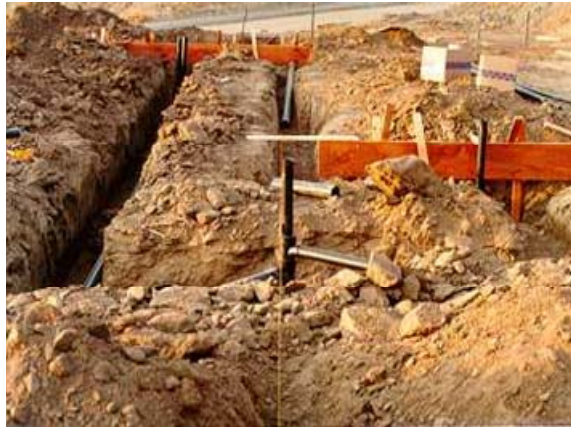
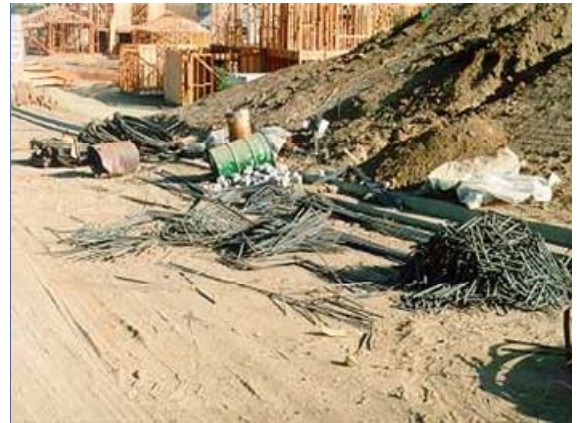
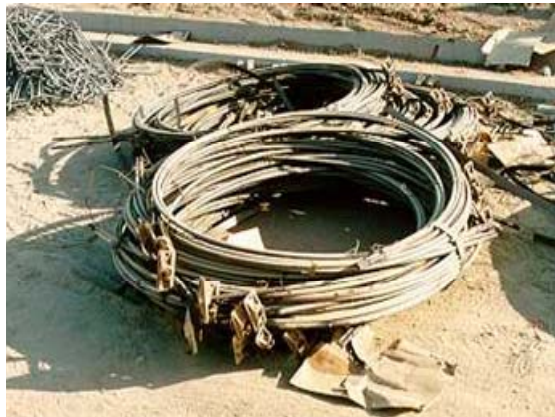
Phase 3, Lot 33

**Phase 3:** Only 3 of the foundation slabs at 20 homes within Phase 3 were completed (15%). Each of these 3 locations had Post-Tension slabs. At 5 lots, Post-Tension cables were observed to be coiled and laying in the dirt without protection from exposure to the elements. The balance 12 lots were in various stages of pre-foundation, pre-reinforcement or pre-pour condition. The 3 completed slabs are in average condition. All other foundation related construction in this Phase should be classified as below average and will require complete re-work to bring up to standard due to abandonment.

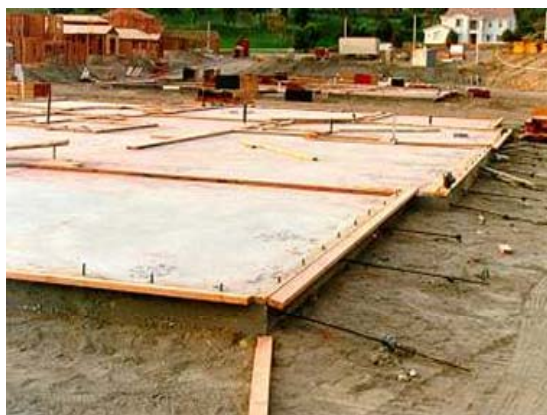
Phase 2, Lot 21

**Phase 2:** All of the foundation and slabs at the 17 homes within Phase 2 were completed Post-Tension slabs. At 10 of the 17 homes (59%) hairline shrinkage cracks were observed at the garages and at the stoop step between the garage and the habitable space. No measurable vertical differential was encountered at these shrinkage crack locations. 2 of 17 slabs (12%) had areas of standing water in the middle of the slab which highlight the imperfection in the levelness of the concrete. Based on the layout of the homes, these low areas are in rooms that will likely receive carpet so ultimate homeowner will likely not feel the slight imperfection. Should hard flooring services be selected in these areas, a floor leveling compound may need to be considered to prevent voids under the flooring. All of the foundations are visual classified as above average.

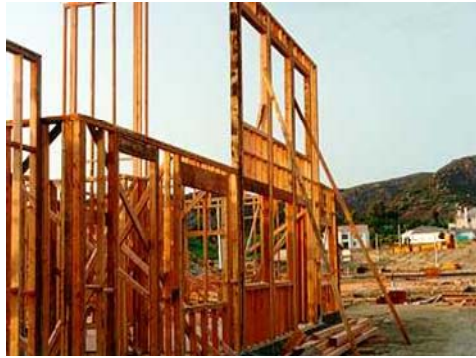
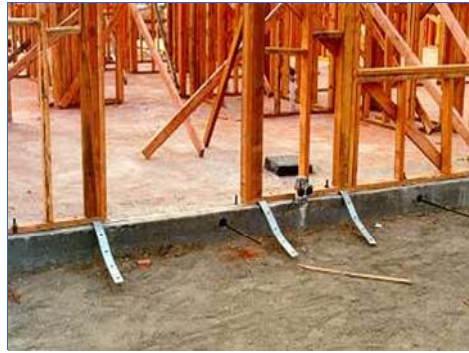
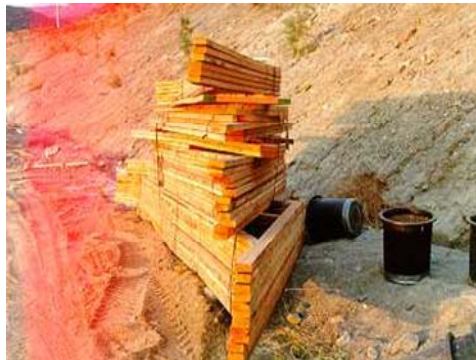
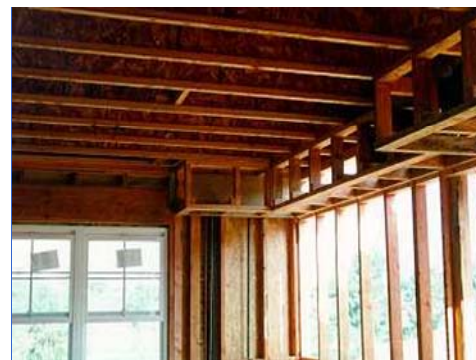
40% of the wood framing structure at this phase is complete. Stacks of lumber are scattered throughout this Phase. Partially erected perimeter walls and interior walls exist. Stacks of pre-manufactured roof truss are laying in the dirt and are unprotected. Exposed framing hardware is not fully nailed or fastened in place and not consistent with the construction drawings. At lot 28 the anchor bolt for the HD hold-down has been bent and will not perform its intended function.

Condition of the framing in Phase 2 is below average. Recommend a full structural evaluation of the in-place framing prior to start up of any new construction operations in this phase.

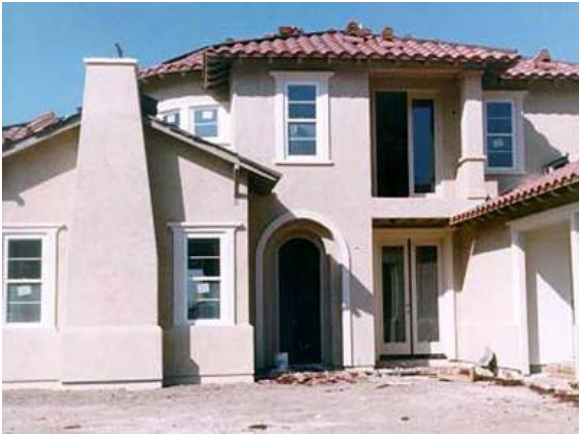
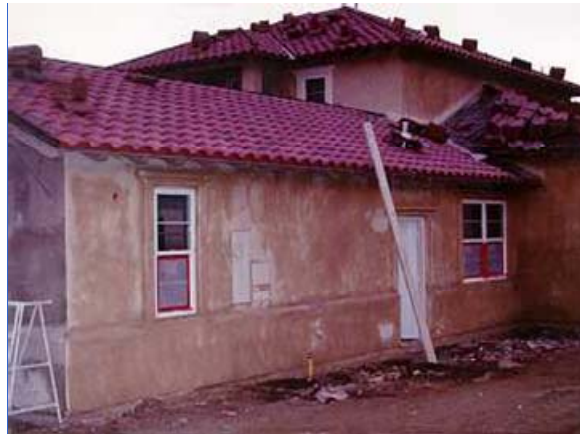
At the 5 completed homes, a low occurrence of stucco cracking was observed, with just minor hairline cracking at 2 exterior door corners. These 2 areas can easily be patched.

The condition of the stucco in Phase 1 is at above average to average.

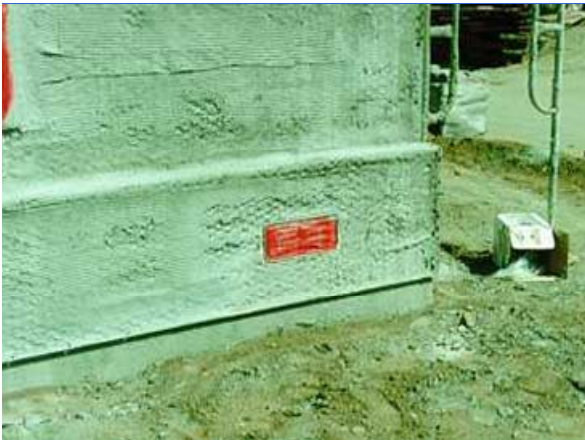
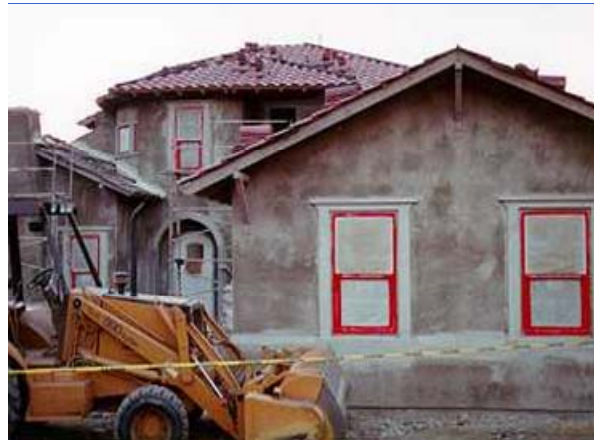
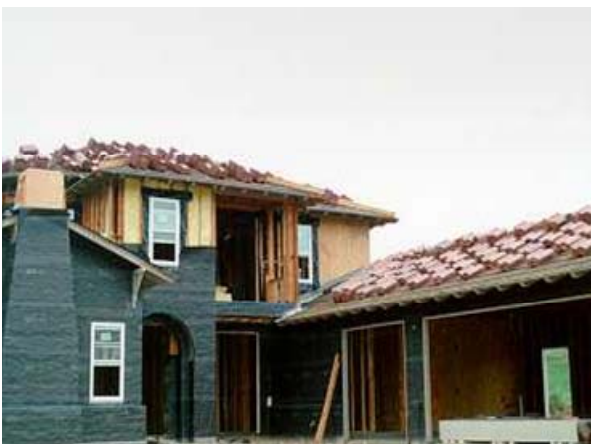
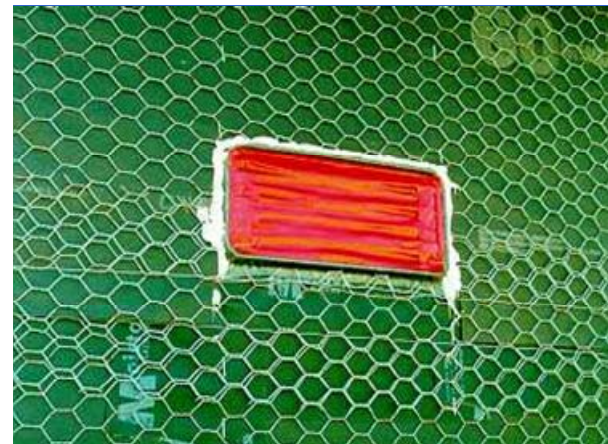
Phase 2

Only 2 homes have had the application of the scratch and brown coat (12%). None of the homes have the application of the finish coat. The remaining 15 homes are in various stages in the application of the building paper and lath.

Above average work quality does exist in the application of the lath and paper at the 15 homes where the paper is exposed. Good application of sealant at penetrations along with proper attention to wire-to-wire and paper-to-paper laps.

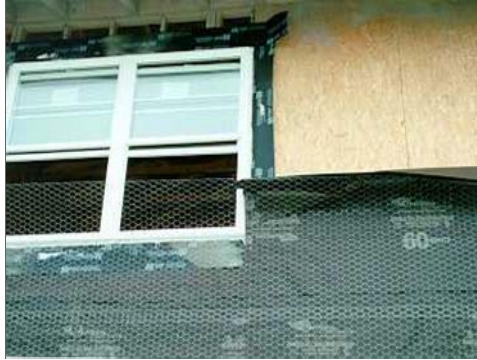
ASTM E-1105 performance testing at 40 first floor horizontal sliding windows was conducted. Testing of the window product resulted in failure at 42% of the manufactured jamb/sill corner window joints. Spray testing of first floor horizontal 30 sliding windows and 5 second floor horizontal sliding windows utilizing our calibrated water rack resulted in a 10% failure due to lack of full bed of sealant behind the window fins during installation or due to damaged building paper during the installation of the windows.

Typical fenestration, Phase 2

Phase 2 windows should be classified as below average. Repairs to both the window product and the installation of the window product should be considered and performed within the first weeks of re-initiation of construction as continued failure will result in damage to finished construction materials and increase risk of defect litigation.

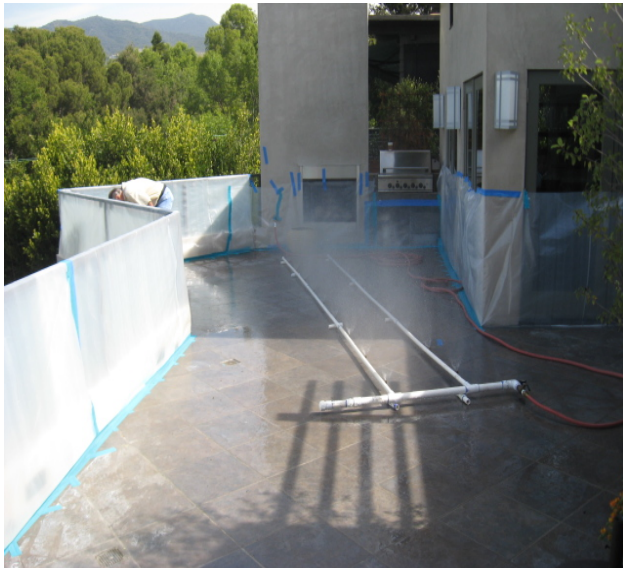
Under the deck, a stain on the gypsum wallboard ceiling at bedroom 2 was observed. A decision was made to utilize Infrared Thermal Imaging Camera to identify any source of water intrusion in lieu of tearing the deck apart. We utilized our calibrated spray rack to simulate rain and used our Thermal Imaging Camera to identify temperature changes, if any, to the ceiling. Our results revealed a significant water event (leak) at the deck drains which resulted in water intrusion into the ceiling cavity of the bedroom below. Per verbal direction from client, we removed a small portion of gypsum wallboard ceiling and observed damage to the OSB deck sheathing as well as a large concentration of Bio-Organic Growth.

Spray test at deck

Based on our testing, we rate the condition of the only completed deck on the entire project as attention required and recommend complete removal and replacement of the deck and finish materials below. Caution should be utilized should consideration be given to re-hiring the same waterproofing and plumbing subcontractor as worked on this deck.

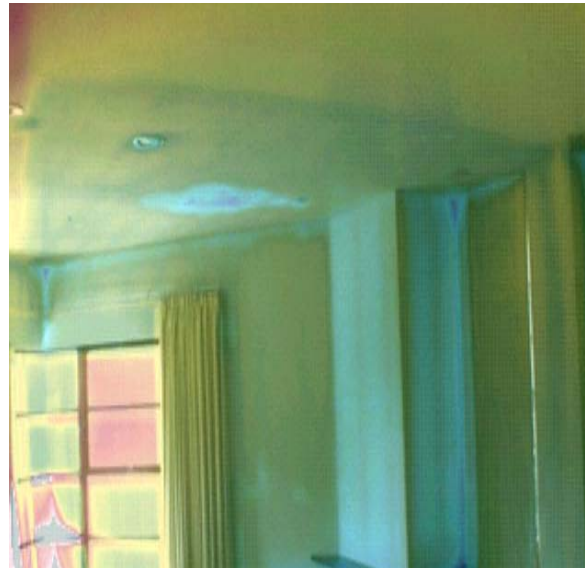
Infrared Thermal Image under deck

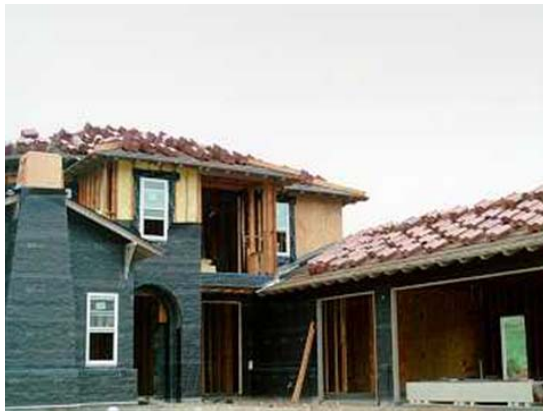
Phase 2 – roof loaded

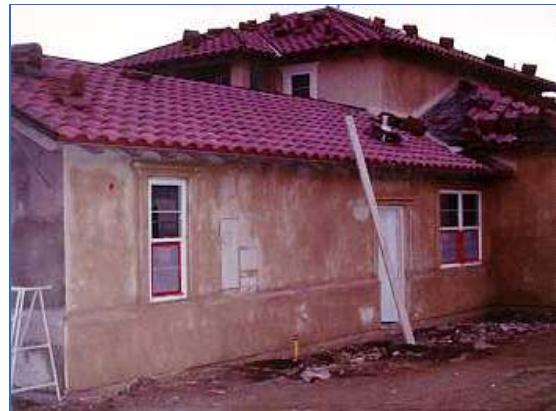
Where installed, the roofing was not complete as “hold-backs” were utilized to accommodate the application of stucco. All observed underlayment was in average condition with proper laps. All sheet metal was in average condition with sealed lap joints. No exposed sheet metal fasteners were observed.

Phase 1 – roof with “hold-back”
