**S.C. WRIGHT CONSTRUCTION, INC.**

**PROJECT CONDITION ASSESSMENT AND EVALUATION REPORT**

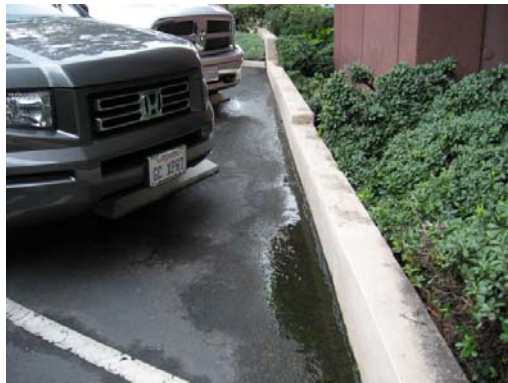
The parking lot contains a total of 32 parking spaces. The parking lot consists of asphalt concrete and is in average to below average condition. Multiple cracks and alligating is observed. Paint striping for the parking stalls is worn and faded. No pot holes were observed. On the west and south elevation of the property, water seepage is observed in the drainage path. The water seepage appears to be on-going as green moss is growing in the waterway. Note, this condition could create a slip and fall hazard and should be considered as attention required.

West elevation water seepage

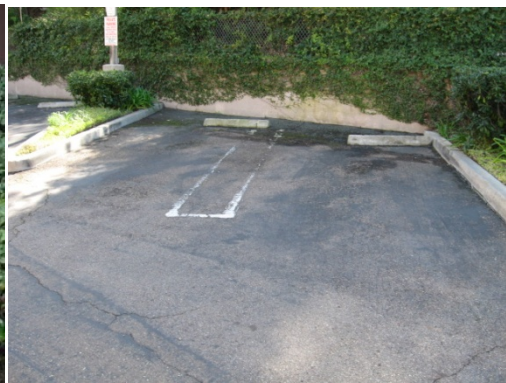
Typical parking condition

Service to the existing parking lot and striping will be required within the next 2 to 5-years. Built-Up Roofing replacement should be contemplated within the next 1 to 2-years. Mechanical units should be scheduled for phased replacement over the next 4 to 5-years due to their age and efficiency.

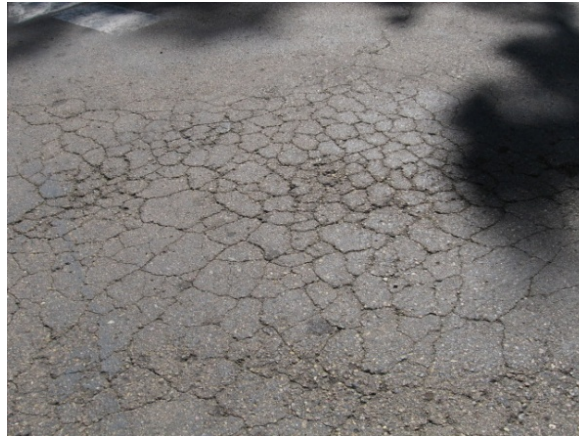
Typical alligatoring at parking

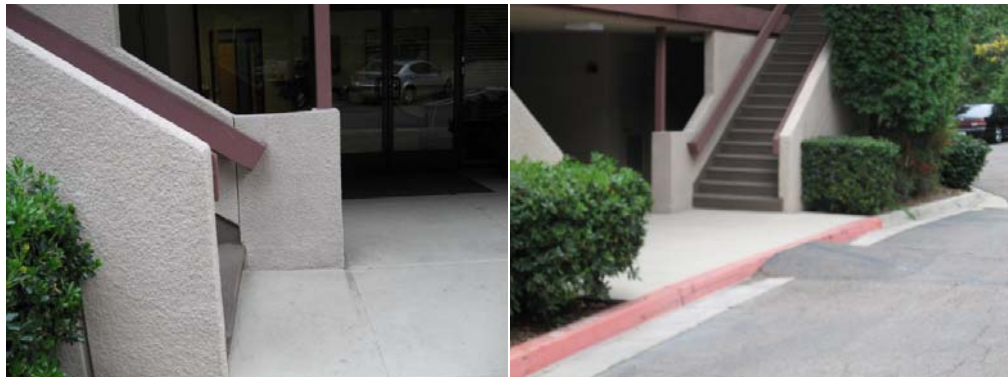
While an exhaustive American Disability Act (ADA) inspection nor code compliance inspection was conducted, it was observed that the as-built stair handrails do not extend a minimum of 12-inches beyond the bottom of the stair landing. In addition, the access ramp from the parking area to the main building entry may be outside of compliance with ADA. Should you desire a full ADA compliant inspection, please contact the undersigned.

Handrail does not extend 12-inches beyond landing  
Access ramp may not be ADA compliant

A full ADA compliance should be conducted on this facility as the age of the building construction and improvements may not be in compliance with existing ADA guidelines. Finally, a full structural, mechanical, plumbing and electrical investigation should be considered to evaluate those areas that were non-accessible during our inspection. Should you desire to retain our services for these areas, please do not hesitate to contact our office.

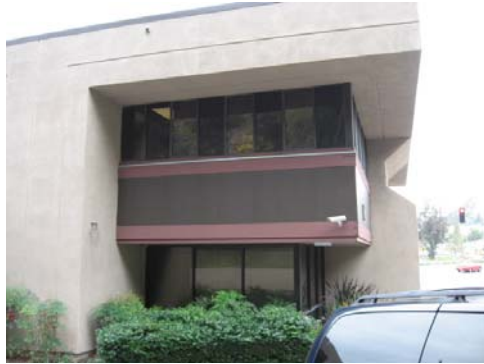
The exterior stucco cladding is in average condition. Cladding is painted and the paint is also viewed as average. The wood accent cladding was observed to be below average with checks and splits which can be easily repaired without interference with the building usage.

Stucco and wood trim cladding

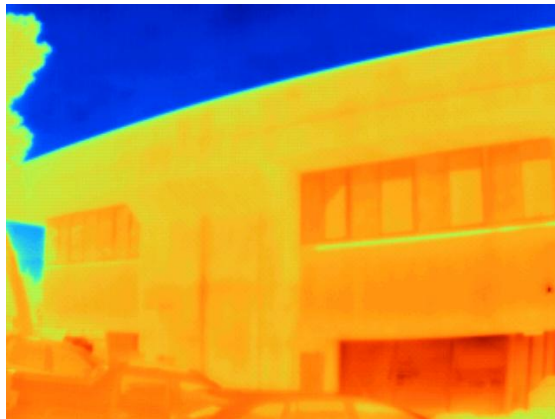
Infrared Thermal Imaging was utilized to identify temperature fluctuations through the exterior wall which could assist at identification of potential water intrusion through the exterior cladding into the wall cavities of the property. This method was utilized due to no interior access being permitted at the time of our inspection. Use of the Thermal Imaging camera revealed no evidence of water intrusion through the exterior cladding.

Thermal Image at west elevation

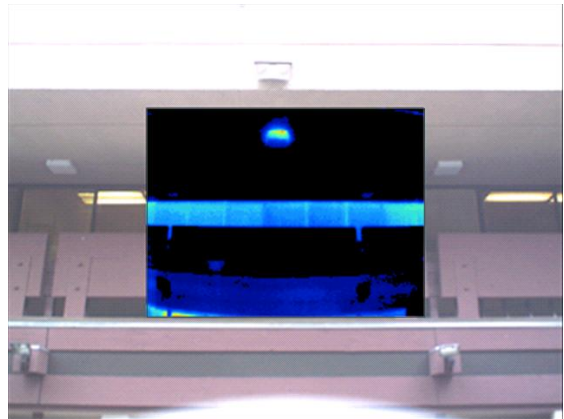
Thermal Image at south elevation

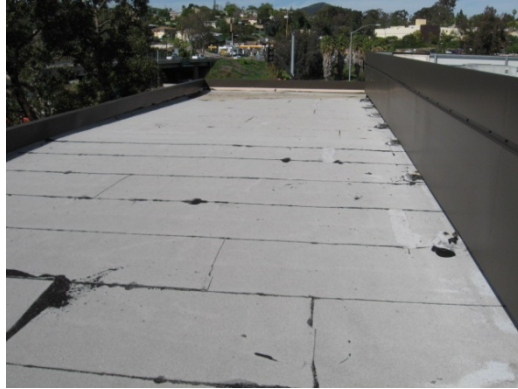
The condition of the flat roof is rated as below average and is likely near the end of its useful service life. Multiple areas of maintenance patching were observed along with fresh mastic and sealants at roof penetrations. The sheet metal parapet cap was in above average condition.

Flat Built-Up Roof

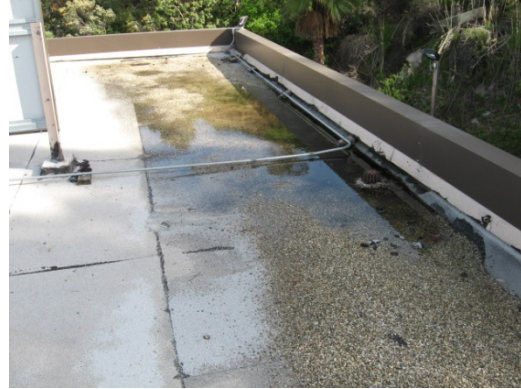
One large section of roof at the south elevation was observed to have a non-operational roof drain. Water was pooling to a depth of 5-inches at this location with a pool of approx. 20-foot in diameter.

Ponding at Built-Up Roof

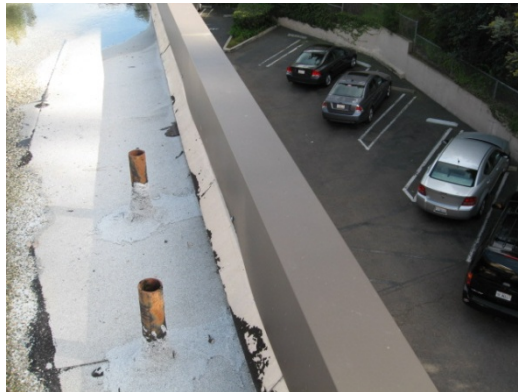
Sheet metal parapet cap.

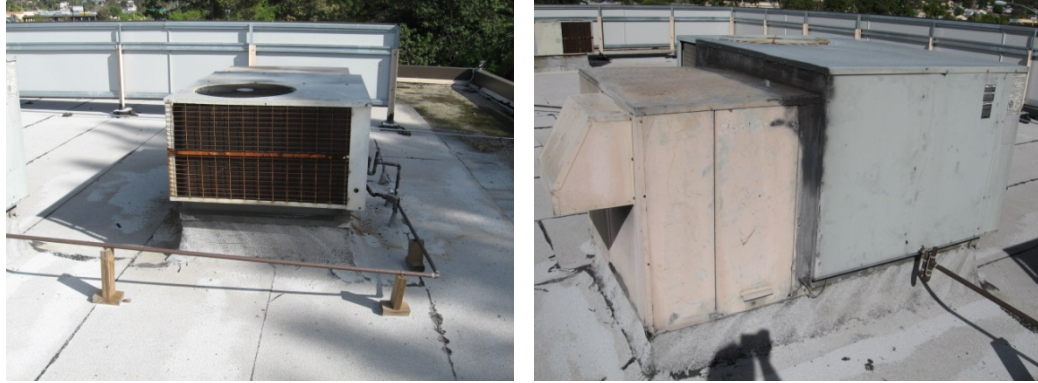
There are eight (8) roof top mounted Trane mechanical units. All units are with manufacture date of August 2000. All units are Trane model number WCX042G100AA. We were unable to cycle the units due to lack of electrical, however these units are at 10-years of age and are nearing the end of their useful service life and should be considered as below average condition.

Roof mounted Trane mechanical units.
