**S.C. WRIGHT CONSTRUCTION, INC.**

**PROJECT CONDITION ASSESSMENT AND EVALUATION REPORT**

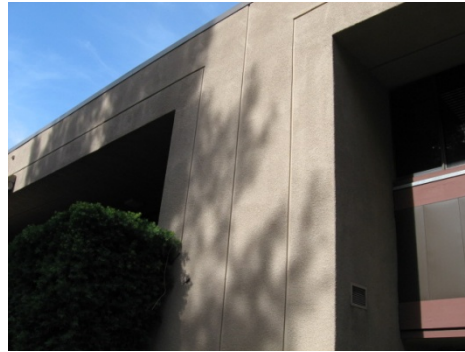
Stucco cladding

Infrared Thermal Imaging was utilized to identify temperature fluctuations through the exterior wall which could assist at identification of potential water intrusion through the exterior cladding into the wall cavities of the property. This method was utilized due to no interior access being permitted at the time of our inspection. Use of the Thermal Imaging camera revealed no evidence of water intrusion through the exterior cladding.

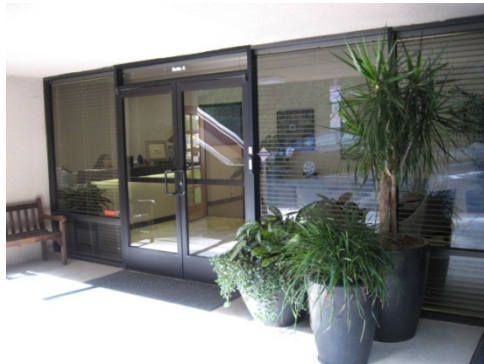
The first floor of the project has typical black aluminum fixed store-front fenestration system. No corrosion to the aluminum was observed. No dislodged or missing rubber gaskets were observed. No cracked, broken or missing glazing panels were observed. Condition of the first floor fenestration system is at Average.

First floor fenestration system

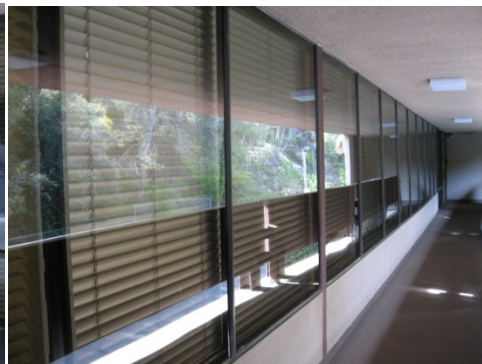
The second floor of the project has a combination of fixed and operable black aluminum store-front fenestrations. Along the south elevation at the stair landing and walkway, the fenestration system is fixed. At the north, east and west elevations, a combination of fixed and horizontal sliding systems were observed. No corrosion to the aluminum was observed. No dislodged or missing rubber gaskets were observed. No cracked, broken or missing glazing panels were observed. Condition of the second floor fenestration system is at average.

Second floor fenestration system

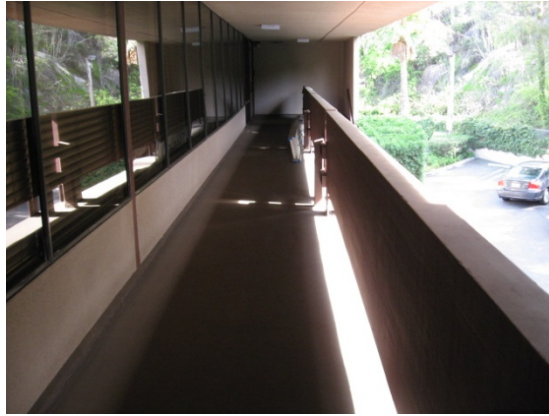
Along the south elevation, a membrane waterproof walkway and dual stair access is present. The condition of the membrane is dirty but above average. Other than the bottom 4 treads of the stairs, the entire walkway and upper portion of stairs is “non-exposed” to weather and protected by roof overhang.

Second floor south elevation walkway
